**PT VARLEY INDONESIA**

***VALVE REFURBISHMENT SPECIALIST***

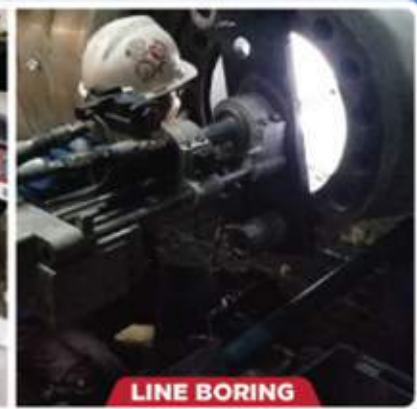
**LINE BORING  
MACHINE**

- **Line Boring Machine**  
*for Main Turbine Valve & HP LP Bypass Valve*
- **Valve Seat Grinding Machine**
- **Flange Facing Machine**
- **Preventest – Online Testing PSV**
- **Solidworks Software – Reverse Engineering**
- **PMI Service**
- **3d Scan**
- **Advanced NDT**
- **Valve Management Database**
- **10 Mobile Container Workshop**

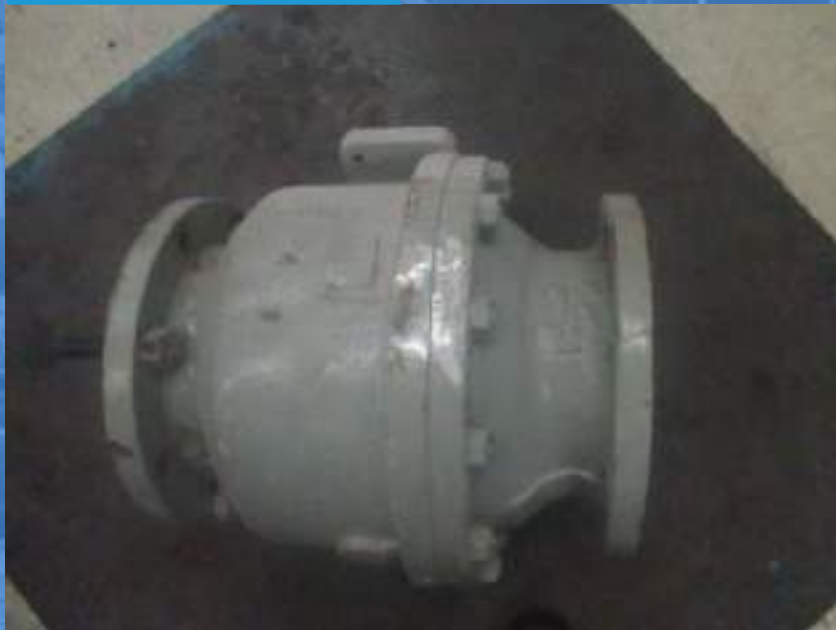
**BEFORE**

**Ball Valve sebelum Repair**

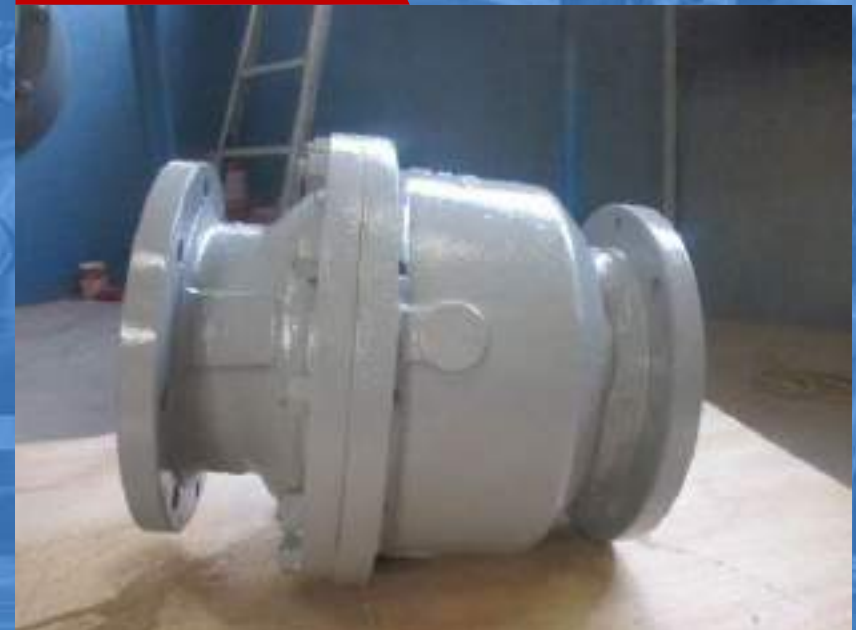
**AFTER**

**Ball Valve setelah repair dan dilakukan pengelasan standar API 6D**

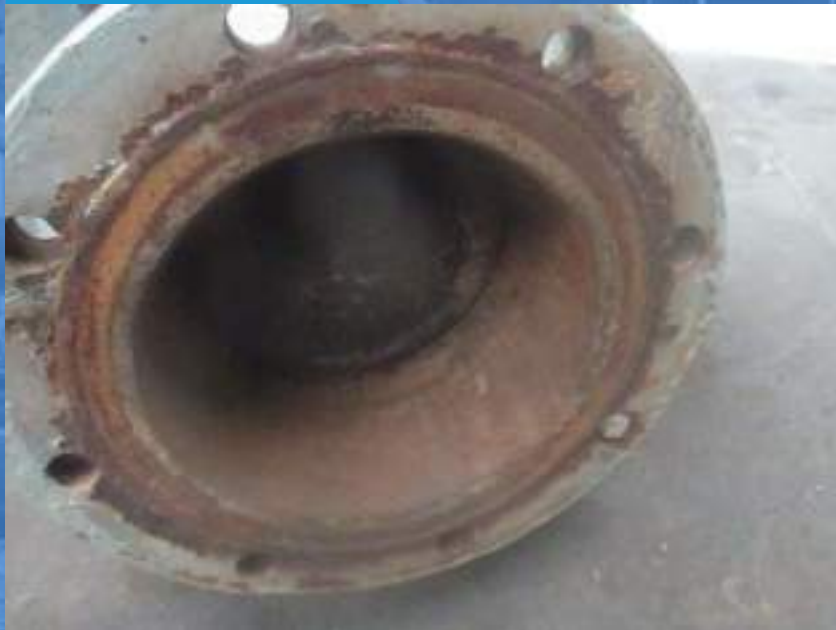
**BEFORE**

RF Flange mengalami korosi cukup parah

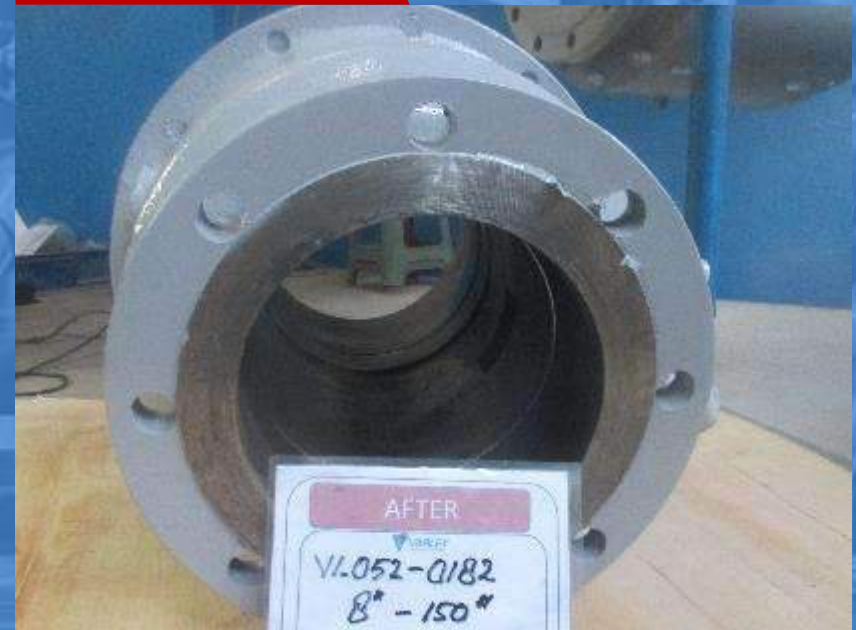
**AFTER**

RF Flange setelah dilakukan Cleaning, Welding & Machining

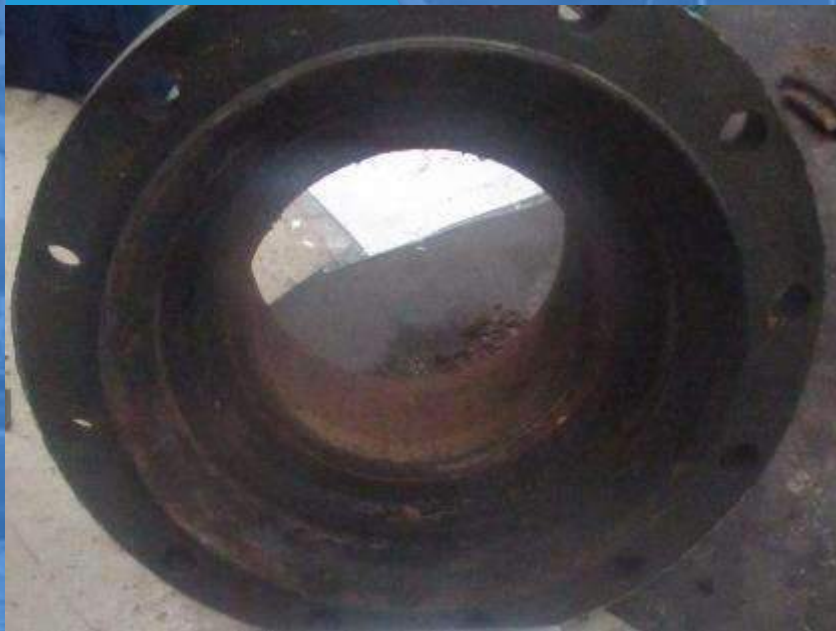
**BEFORE**

Seat pocket terpapar cairan

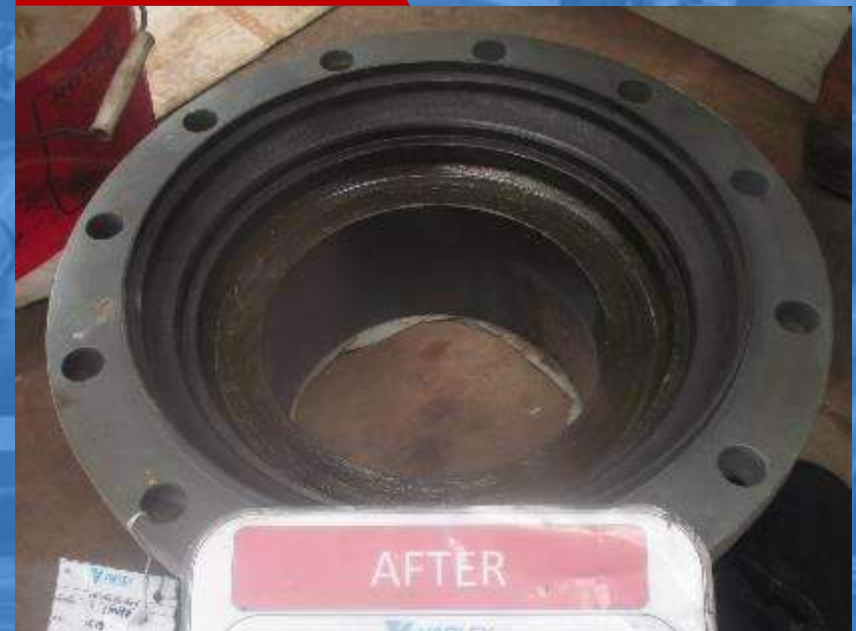
**AFTER**

Seat Pocket setelah dilakukan  
Cleaning and Polishing

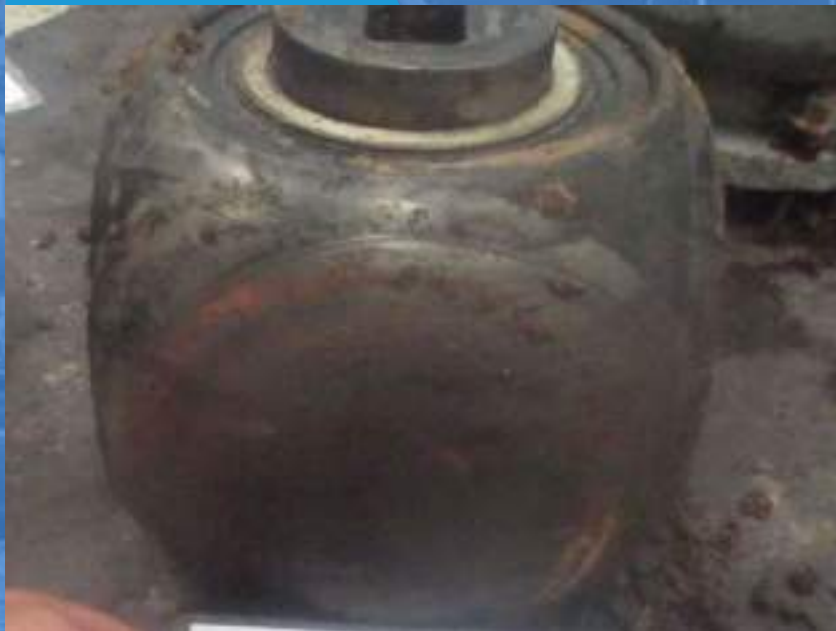
**BEFORE**

**Ball – Permukaan contact area mengalami scratch**

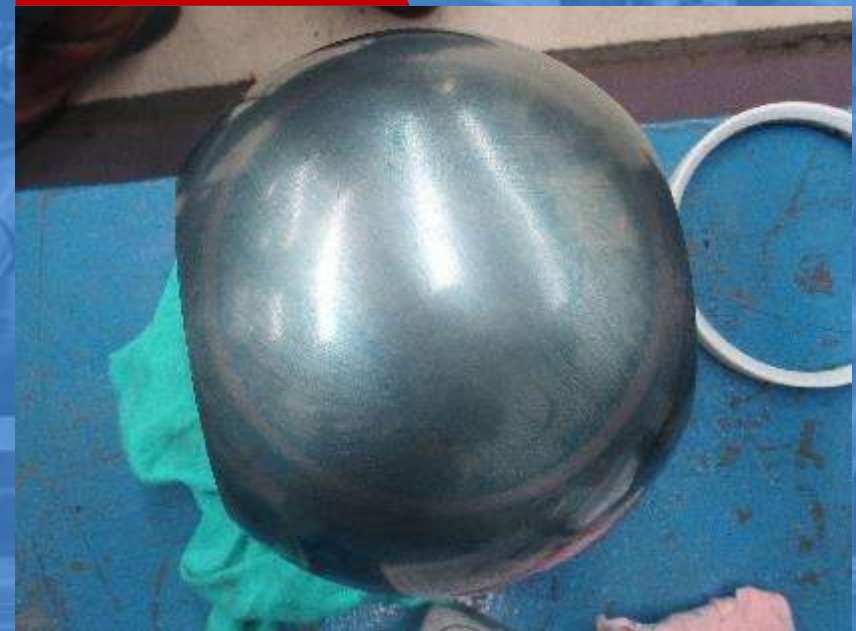
**AFTER**

**Ball setelah dilakukan Welding, Machining, Lapping & Hardchrome**

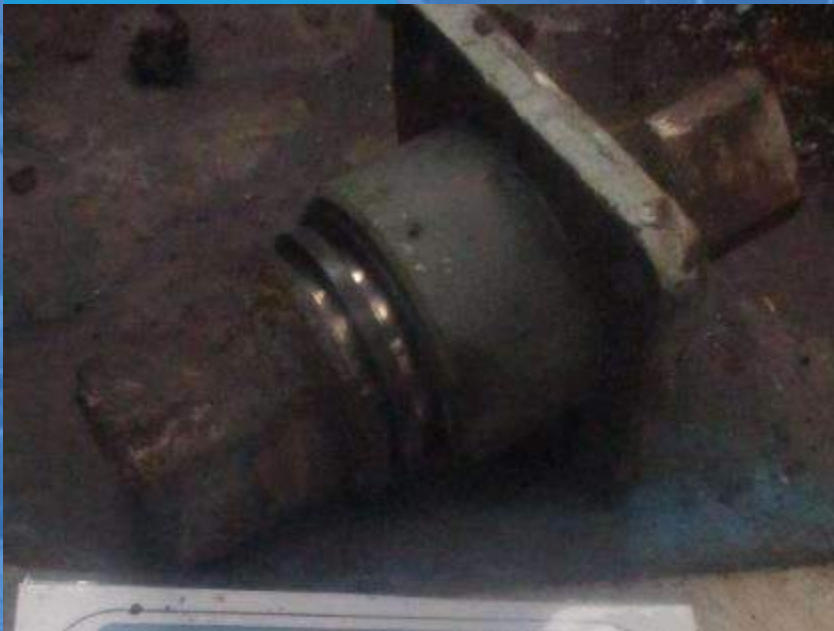
**BEFORE**

**Stem terdapat Scratch  
sedalam  $\pm 0.01$  mm**

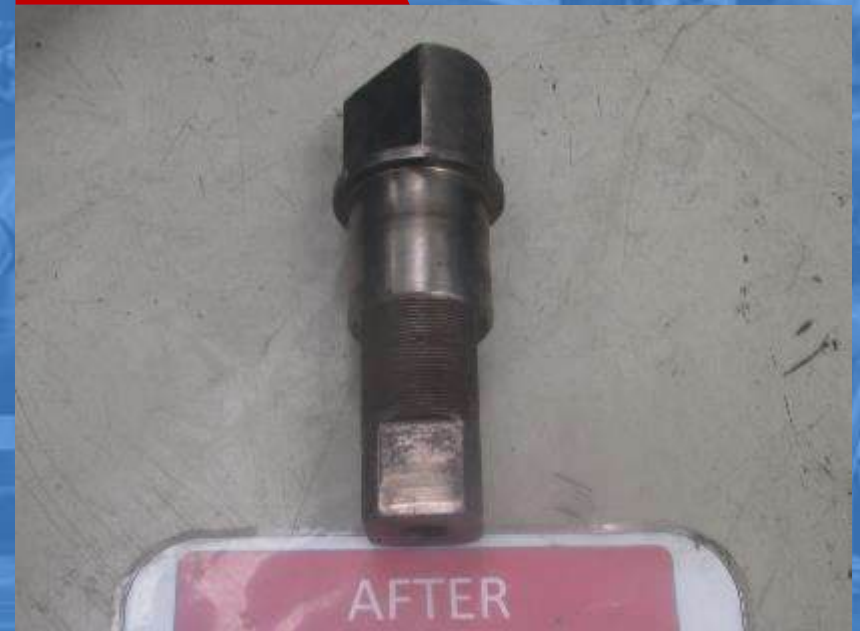
**AFTER**

**Stem setelah dilakukan  
Cleaning dan Polishing**

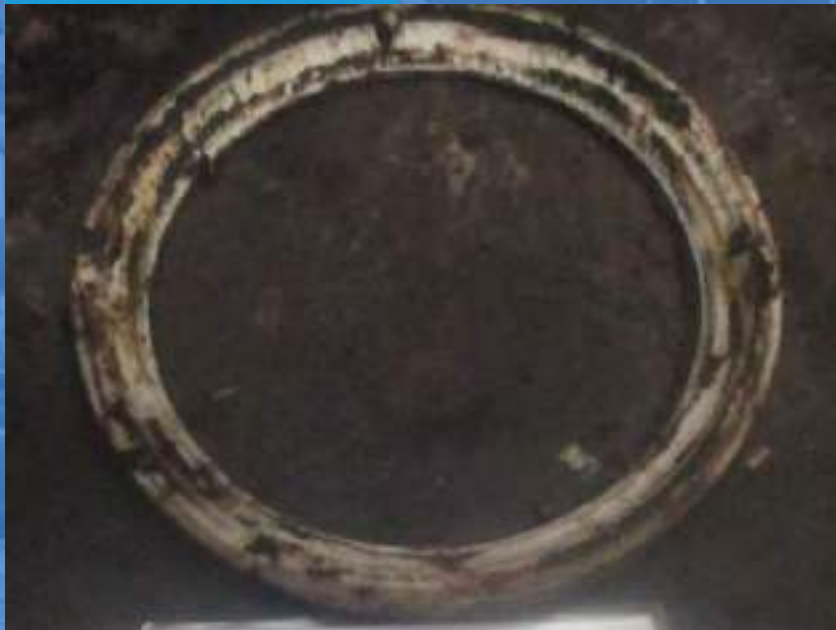
**BEFORE**

**Seat Insert was Compressed and Scratched**

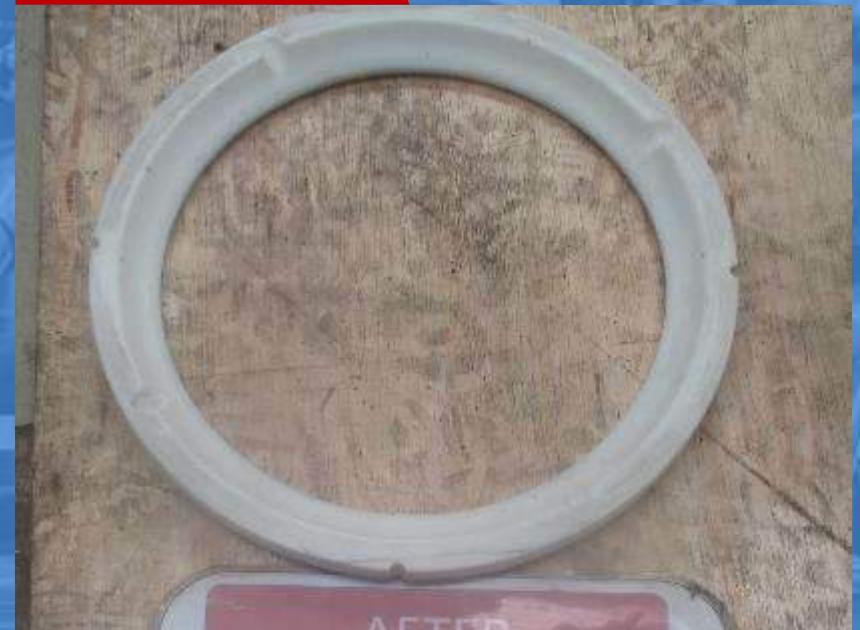
**AFTER**

**Seat Insert ganti baru**

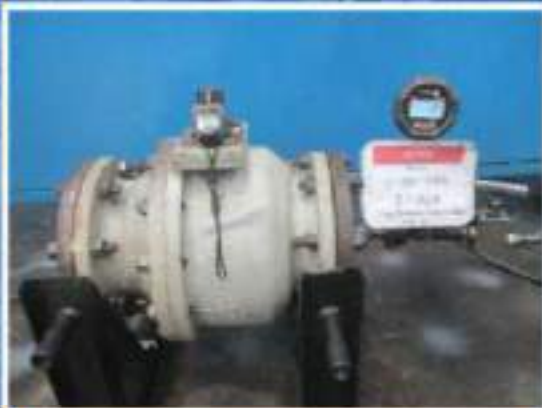
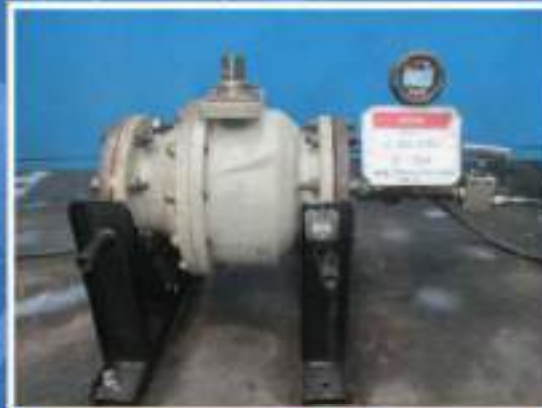
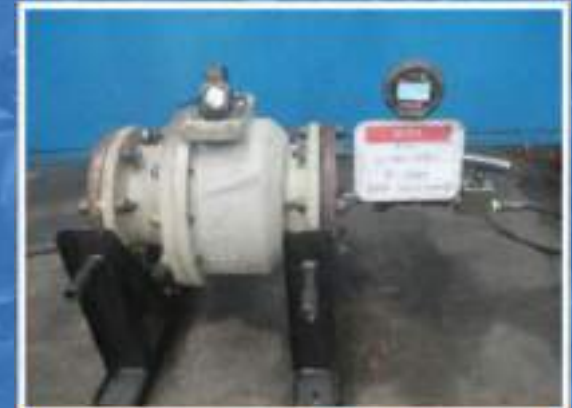
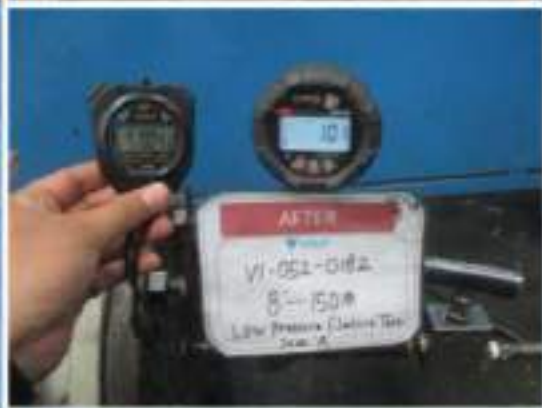
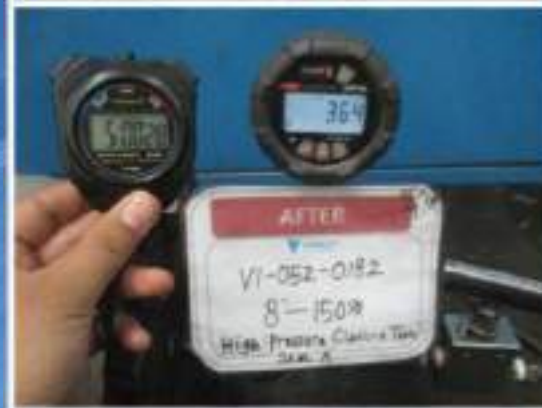
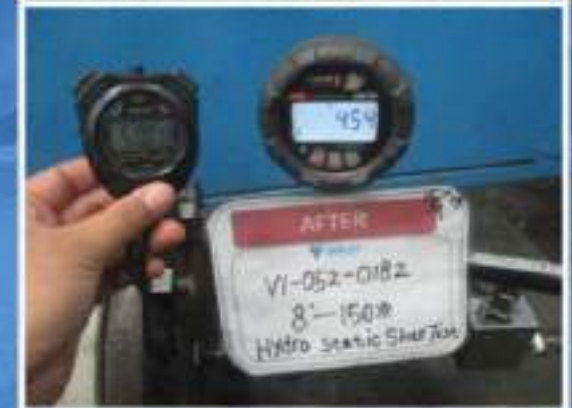
# TESTING PHOTO RECORDS

**Low Pressure Closure  
Test Standar :  
80-100 Psig**

**High Pressure Closure  
Test Standar :  
314 Psig**

**Hydrostatic Shell Test  
Standar : 428 Psig**
